# Manhole Inspection Summary

Manhole # S41G2\_013MH

Insp Date: **3/31/08 10:34 AM**

**Location** Address: **Capstan Ct. (at parking lot of Bay Brookk Elementa**

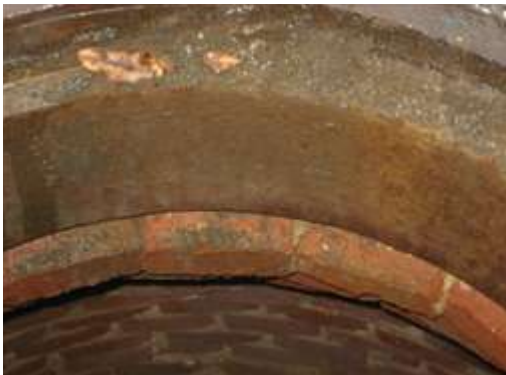
Defect 2

**Frame** Offset: **0** (in.) Condition: ☒ Sound ☐ Cracked ☐ Leaks

Frame offset

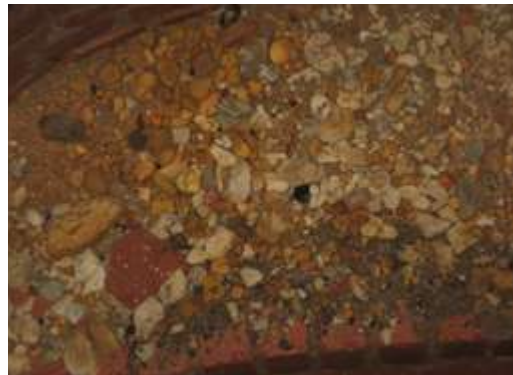
Defect 1

Condition: ☐ Sound ☐ Cracked ☐ Root Intrusion ☐ Deteriorated ☐ Leaks ☒ **Debris**

debris

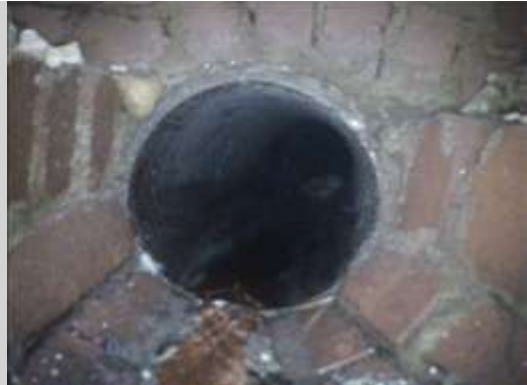
12 O'Clock Outflow

8 in. Circular Gravity Sewer  
Pipe Out @ 12 O'Clock

Pipe Height: **9.6** (in.) Rod and Bar (Angled)

Pipe Material: **DIP/CI** ☐ Pipe Lined

Invert Depth: **4.98** (ft.) Flow Characteristics: **Slow**

Deposits: ☒ None ☐ Mud ☐ Sludge ☐ Debris ☐ Grease

Infiltration: **None** Pipe Seal Cond: **Sound**

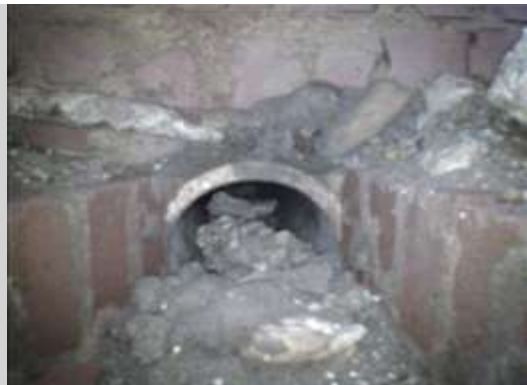
3 O'Clock Inflow

6 in. Circular Service Sewer  
Pipe In @ 3 O'Clock

Deposits: ☐ None ☒ **Mud** ☐ Sludge ☒ **Debris** ☐ Grease

Silt Depth: **2** (in.) Deposits Extent: **Heavy**

Infiltration: **None** Pipe Seal Cond: **Sound**

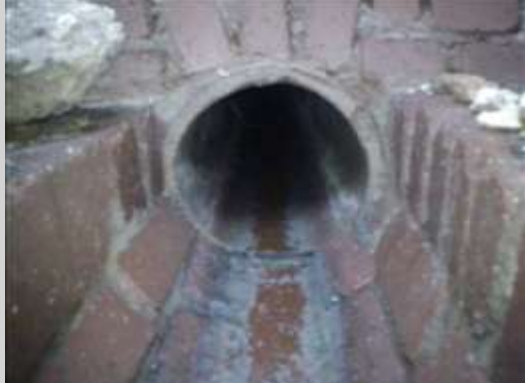
6 O'Clock Inflow

8 in. Circular Gravity Sewer

Pipe In @ 6 O'Clock

Invert Depth: **4.97** (ft.) Flow Characteristics: **Slow**

Deposits: ☒ None ☐ Mud ☐ Sludge ☐ Debris ☐ Grease

Infiltration: **None** Pipe Seal Cond: **Sound**
